**RE: South Dayton Dump photographs**

S. Dayton Dump  
Ohio EPA Observed Drum Locations, Feb. 7, 2008

S. Dayton Dump  
Observed Drums Feb. 7, 2008 compared to April 1973

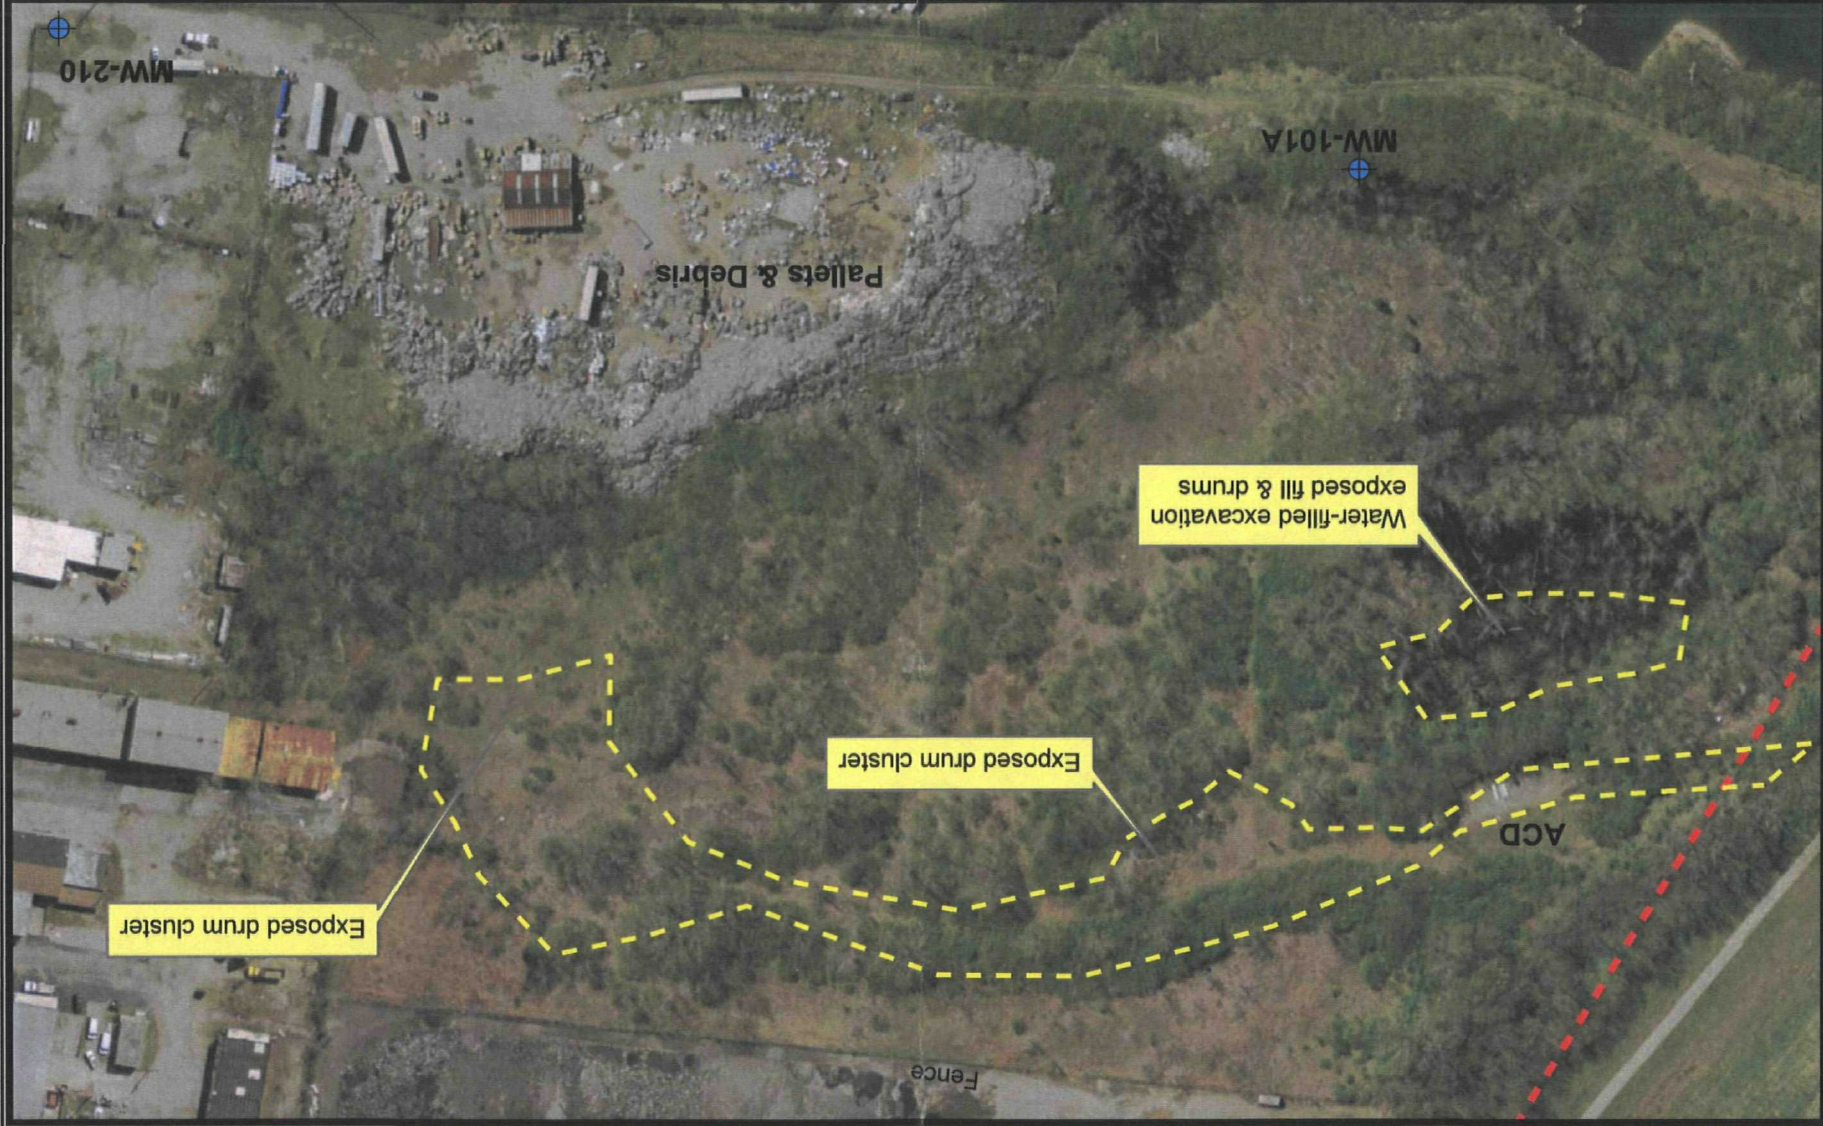
Figure 1

On February 7<sup>th</sup> Ohio EPA did a walk-over of the site. Of particular notice, we observed clusters of rusted drums in two distinct areas. The first area was an east to west trending depression south of Valley Asphalt, Figure 1. The second area was a depression south of the former air curtain destructor. These features correspond to the extent of a former haul road, as observed in the attached 1973 aerial photograph, Figure 2. The enclosed CD contains photographs of these and other features.
